**Cultural Resource Inventory and Evaluation Report
of the W.R. Grace Export Plant
City of Libby,
Lincoln County, Montana**

**Joan L. Brownell
Billings Montana**

August 2000

**Report prepared for URS Corporation
Denver, Colorado**

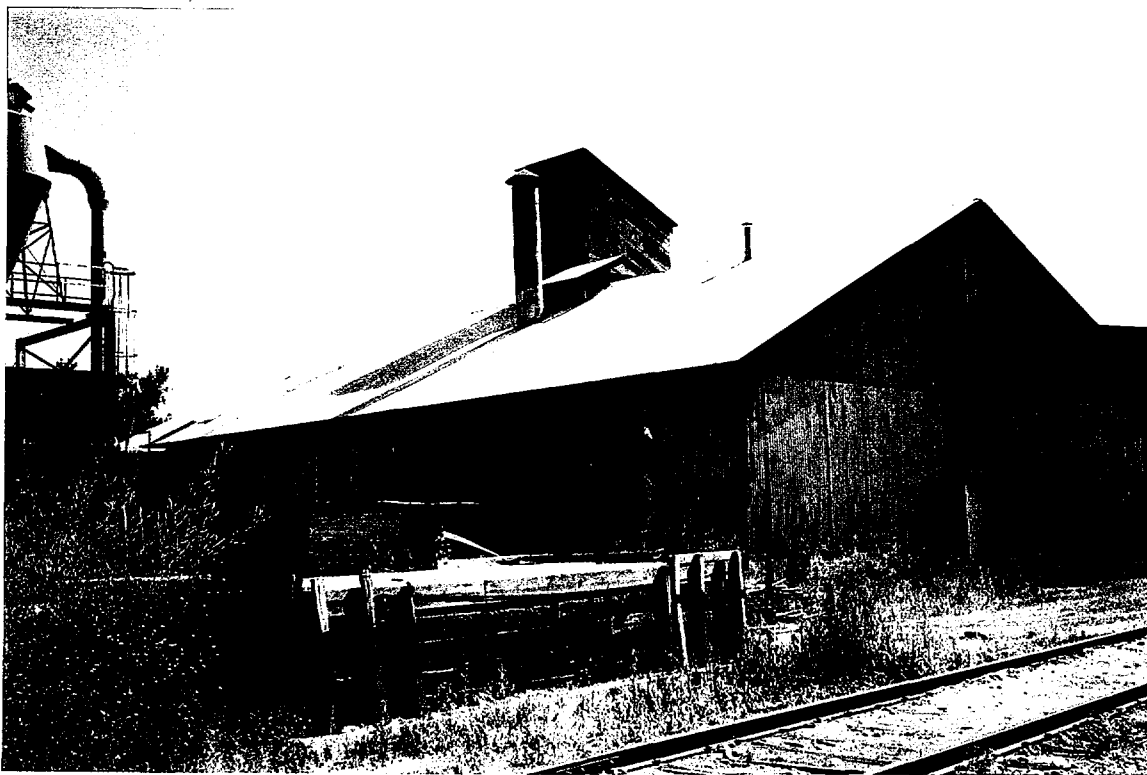
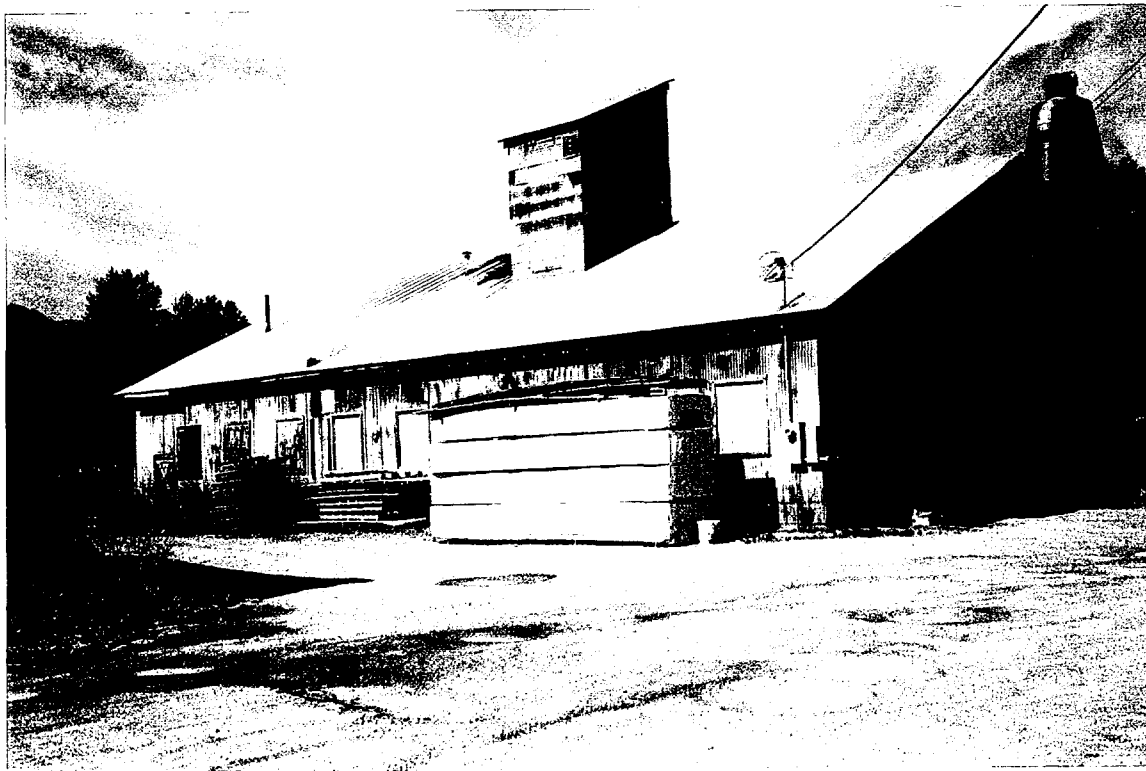
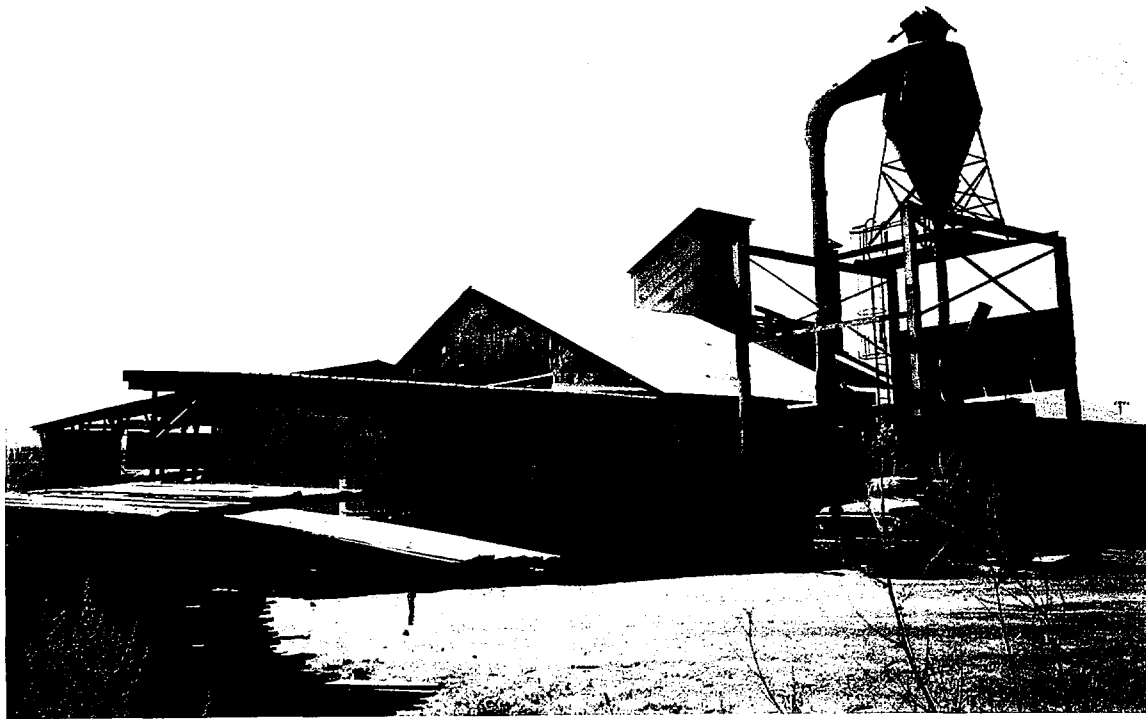
This one-story rectangular wood frame historic building sits on a low concrete foundation (Figures 5, 6 and 7). The main building measures 80 feet north/south by 32 feet east west. The building has a gable roof covered with corrugated metal siding with slightly extended eaves and visible rafter ends. A superstructure sits near the center of the ridgeline on the east roof slope. It measures 10x10 feet, has a shed roof and is covered with corrugated steel. A small entry is located on its south wall. On the west slope near the center of the ridgeline is a shed roofed wood louvered vent and a tall protruding stovepipe.

All walls are clad with corrugated metal. A row of window openings (boarded shut with plywood) span the east and west walls with nine openings on the east wall and eight on the west wall. The east wall also contains a wood door at its south end. The west wall holds a loading wood door mid-wall at its north end. The south end wall has a centered wood door topped by triple multi-paned window (panes missing). Vertical beadboard tongue and groove double doors are centered on the north end wall surrounded by a large frame opening now infilled with plywood (original opening?).

A steel frame structure (19 feet x16 feet) also stands 10 feet west of the building towards the north end. This steel frame functions as a truck ramp and holds a cyclone dust separator that is connected to the main building by a large pipe.

Figure 5. Expanding Plant, south and west elevations, view to north/northeast

Figure 6. Expanding plant, north and east elevations, view to southwest

the planer awning and cyclone structure were built around 1986 by Jim Ray. Burnett enclosed the planer around 1994 (Burnett 2000).

The integrity of this building has been slightly compromised by the closure of most openings and the introduction in its northwest corner of a steel awning, planer enclosure and the cyclone structure. It is in fair condition.

Figure 7. Expanding Plant, north and west elevations, view to southeast

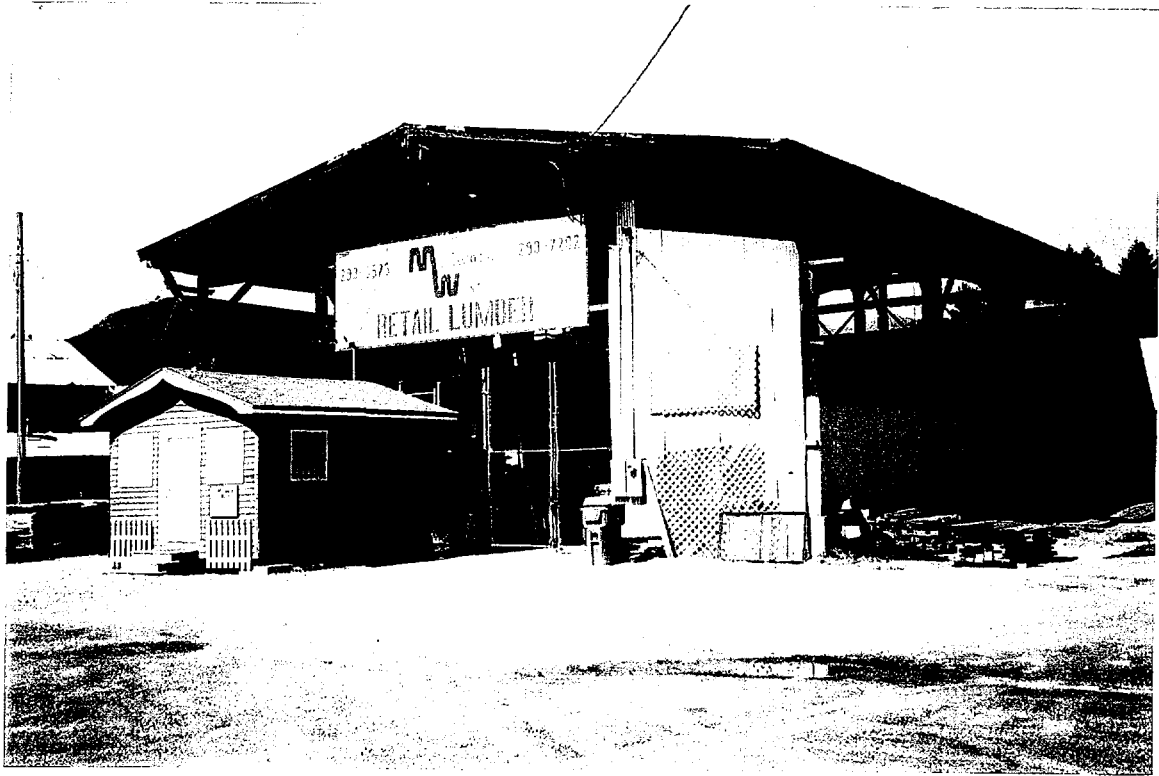
The building is in fair condition and retains good integrity with minor alterations to wall coverings.

Figure 8. Raw Storage Building, north and east elevations, view to west

Figure 9. Raw Storage Building, south and west elevations, view to northeast

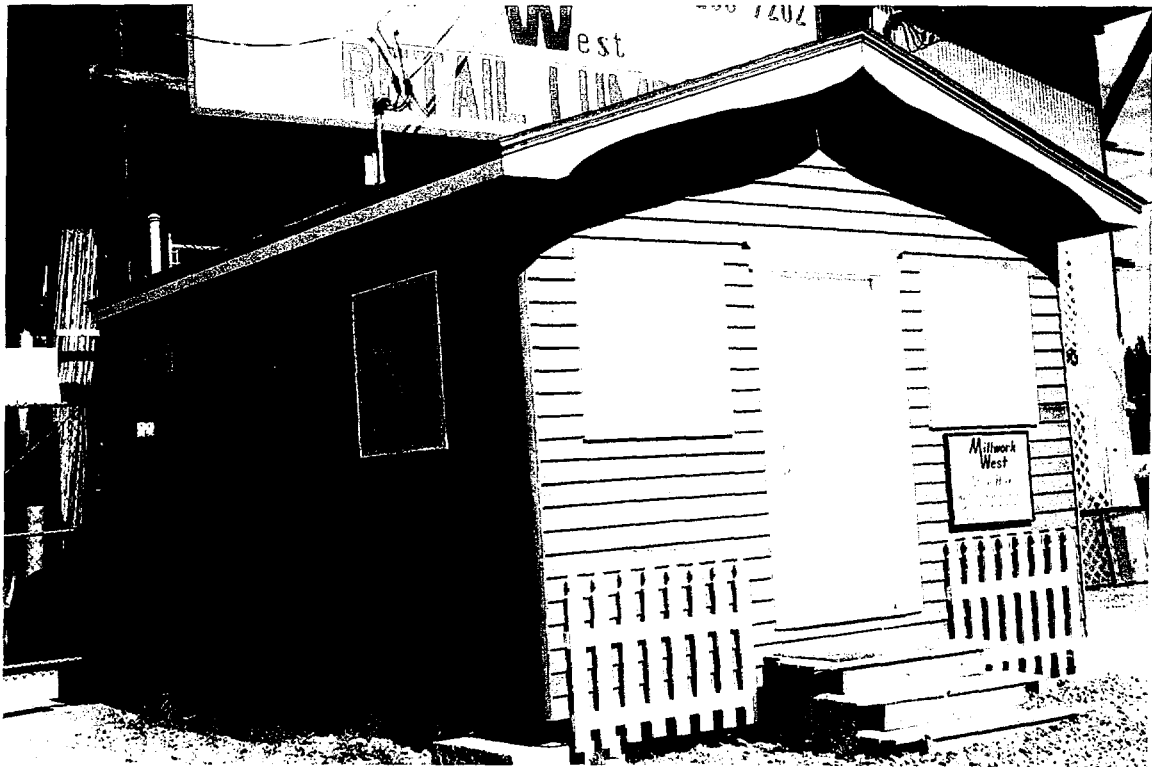
This modern small wood frame rectangular building measures 14 feet north/south by 16 feet east/west (Figure 10). The building has a gable roof covered with asphalt shingles and extended enclosed eaves. The building sits on concrete pads and has I beams for floor joists. It is clad overall with shiplap siding with corner boards, with vertical board on the upper portion of the south wall. Both side walls have a nine light window covered with metal mesh. The west end wall is symmetrical with a centered door entry framed to either side by a nine light window covered with metal mesh. Decorative elements to the building include architrave trim and fluted columns at the door frame, white picket fence wall sections to either side of the door and a scalloped vergeboard. Three wood stairs and a small wood stoop approach the doorway. Mel Burnett built this building on site around 1994 (Burnett 2000). It is in good condition.

Figure 10. Office, south and east elevations, view to northwest

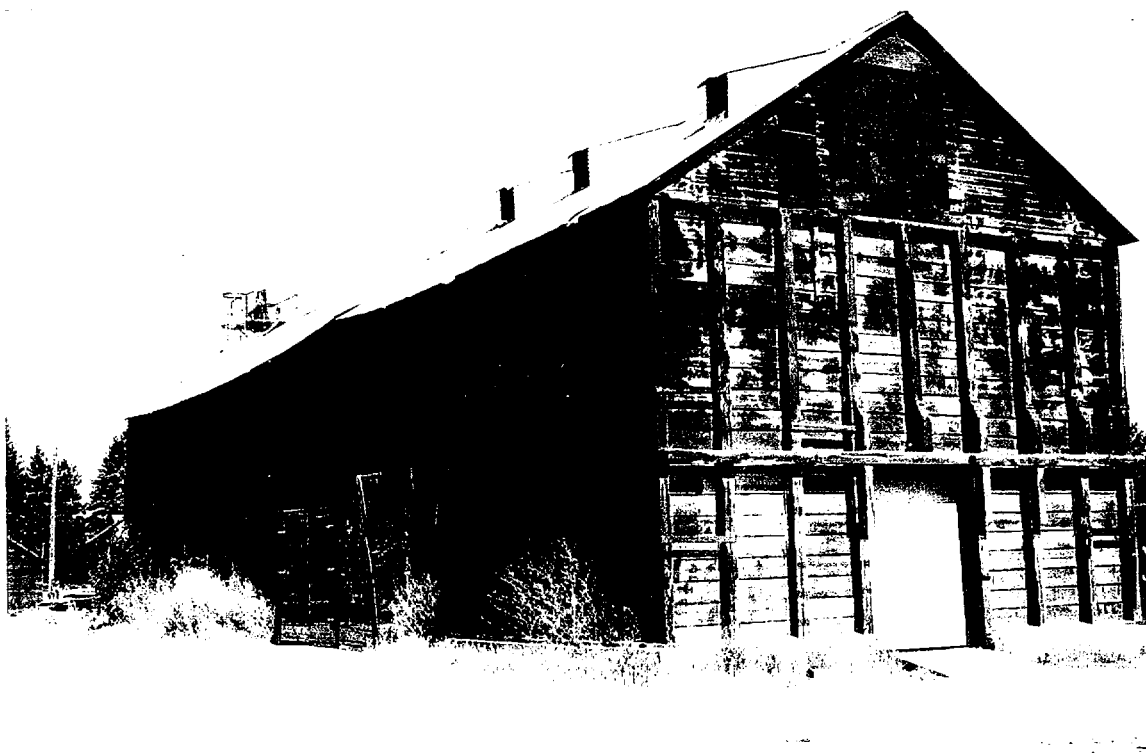
The building sits on a high concrete foundation with steel L beams set on top of the concrete. The building is interior sheathed with 12X2 feet boards with external 8x8 feet beams with wall reinforced with cable. The east gable end is covered with horizontal boards and has openings now boarded shut with plywood. The east end wall holds a centered sliding wood door (covered with metal plate). A metal ramp approaches the sliding door.

In front of the east end of the building is a concrete ramp (24 feet by 12 feet) that approaches a concrete dump hopper. The hopper is sheltered by a open sided gable roof shed supported by wood posts. A bucket elevator is centered against the east end wall and protrudes through the gable roof to above the gable roof. A compressor sits on a platform at the top of the elevator. A metal stair protected by a metal cage climb the wall to the top of the elevator. Chain link fence surrounds the hopper and elevator .

Figure 11. Bagging plant, south and east elevations, view to northwest

Figure 12. Bagging Plant, north and west elevations, view to south/southeast

The building is in fair condition and retains its historic appearance and character.

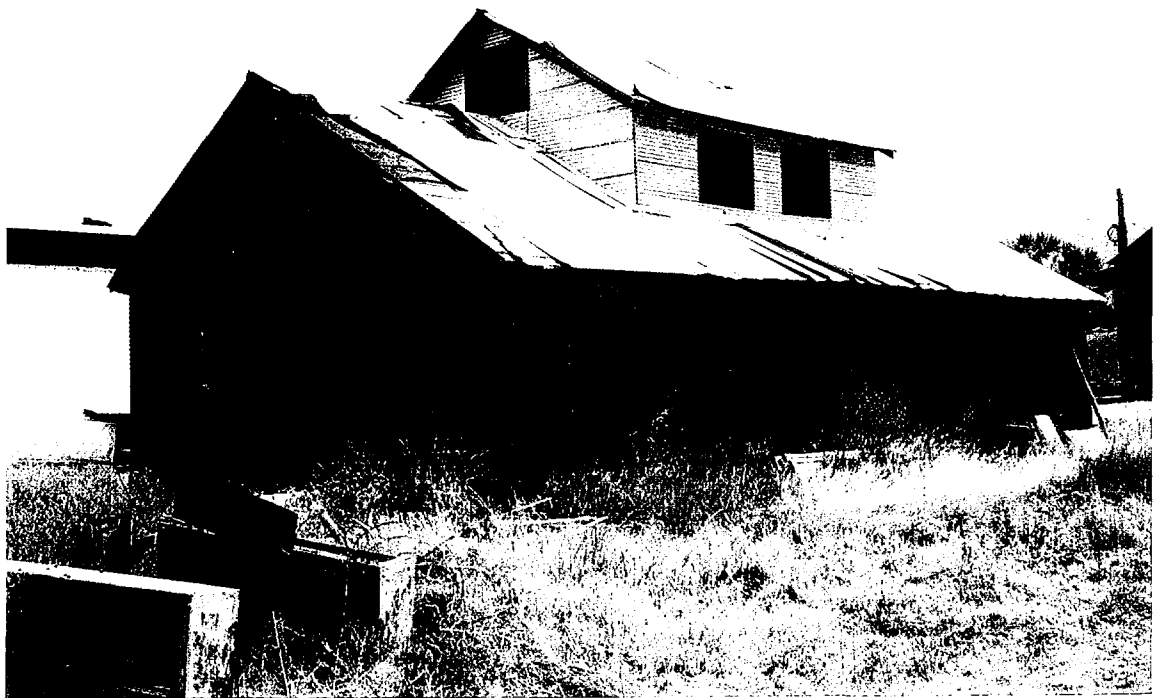
This wood frame rectangular gabled roof historic building sits on a low concrete foundation and measures 32 north/south by 56 east/west (Figures 15 and 16). The gable roof is covered with corrugated

The building is in fair condition and retains overall integrity with minor alterations of boarding shut most openings.

Figure 15. Storage Building, north and east elevations, view to southwest

Figure 16. Storage Building, south and west elevations, view to northeast

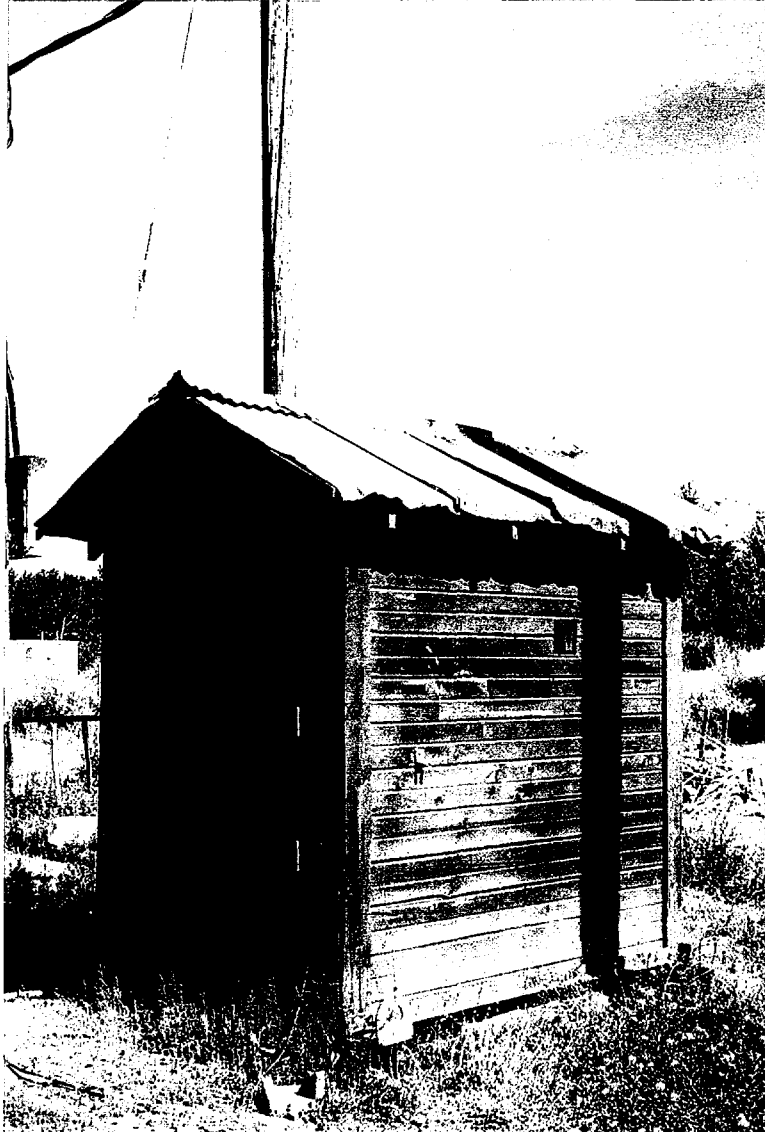
This small modern shed measures 5 feet by 7 feet and sits on I-beams (Figure 17). It has a gable roof covered with corrugated metal, a metal ridgecap and extended eaves with exposed rafters. The shed is clad with beveled tongue and groove shiplap board with corner boards. The south wall contains a wood plank door. The interior of the shed is finished with tongue and groove.

The shed is in good condition. This shed was built by Mel Burnett with materials he donated for the dry kiln project at the site location (Burnett 2000).

Figure 17. Shed, south and east elevations, view to northwest

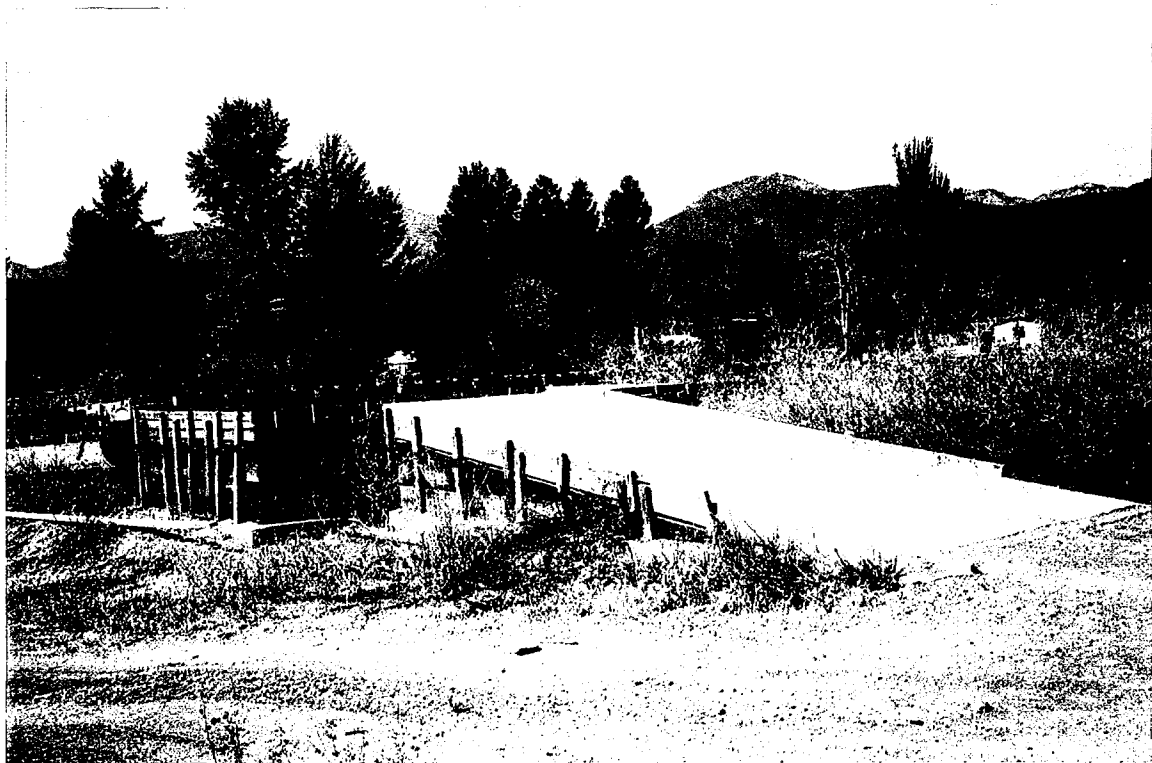
This modern loading ramp consists of a concrete platform that measures 10.5 feet by 19 feet and a concrete ramp that measures 20 feet by 10 feet (Figure 19). The platform is formed by horizontal railroad ties for side walls filled in with gravels. The ramp side wall are horizontal boards. All side walls are held in place by vertical studs slotted through iron clamps.

Mel Burnett built this loading dock in 1996 (Burnett 2000)

Figure 19. Loading Dock (west), north and east elevations, view to south/southwest
